PORT OF FLEETWOOD

NOTICE to MARINERS 2 of 2019 Channel constant

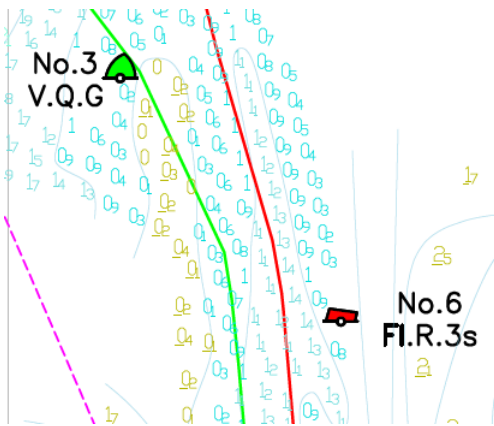
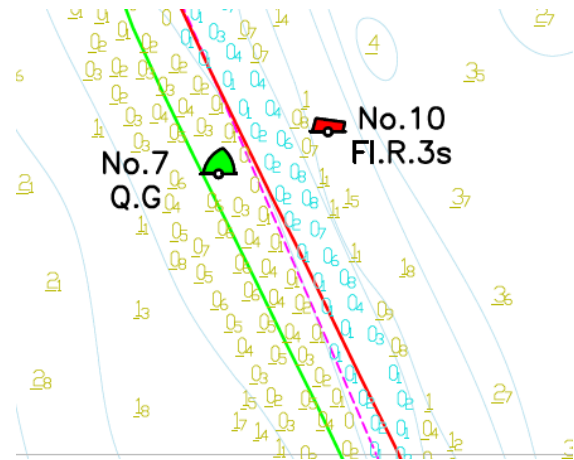
Mariners are hereby advised that following survey the controlling depth for the Fleetwood Channel between the Fairway and No.20 buoys lays in the vicinity of the No. 3 buoy and No 7 buoy where the channel dries up to 0.4m and 0.6m above Chart Datum.
